## 4. Structural Systems Performance

*The dominant causes of structural failure observed by the MAT included storm surge, waves, floodborne debris, and wind. Structural damage due to erosion was also common on the barrier islands. Damage occurred to residential buildings (single- and multi-family housing), commercial buildings, and critical and essential facilities.*

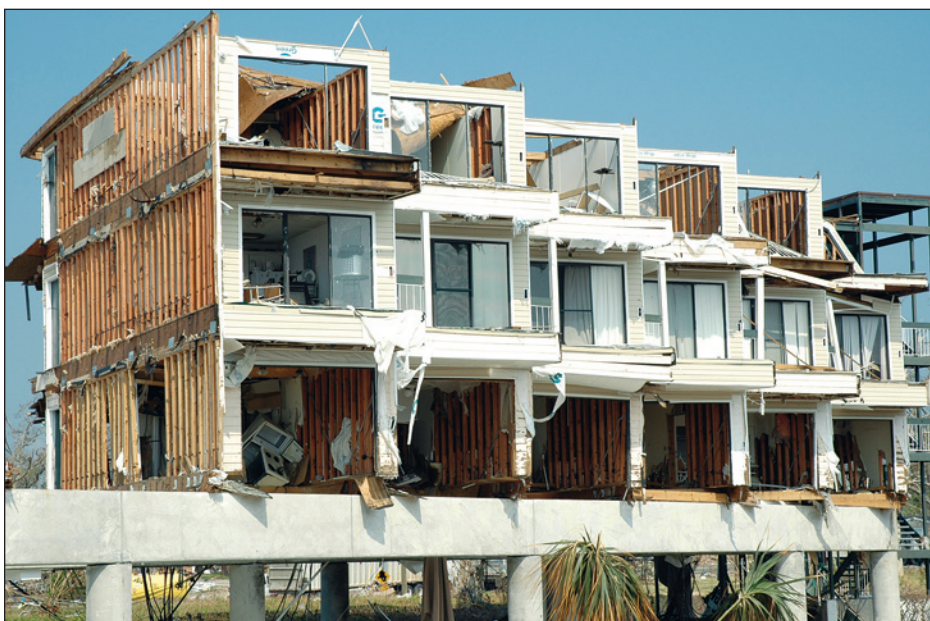
The condominium in Figures 4-51 and 4-52 was supported on heavy reinforced concrete columns and beams, but progressively failed from lateral and uplift wave loads on the lower unit load-bearing walls and floors. Note that wind impacts to the building, apparent at the roof and upper stories, may have also contributed to building damage.

Figure 4-52  
Another view of the  
condominium shown in  
Figure 4-51 (Gulfport,  
Mississippi)

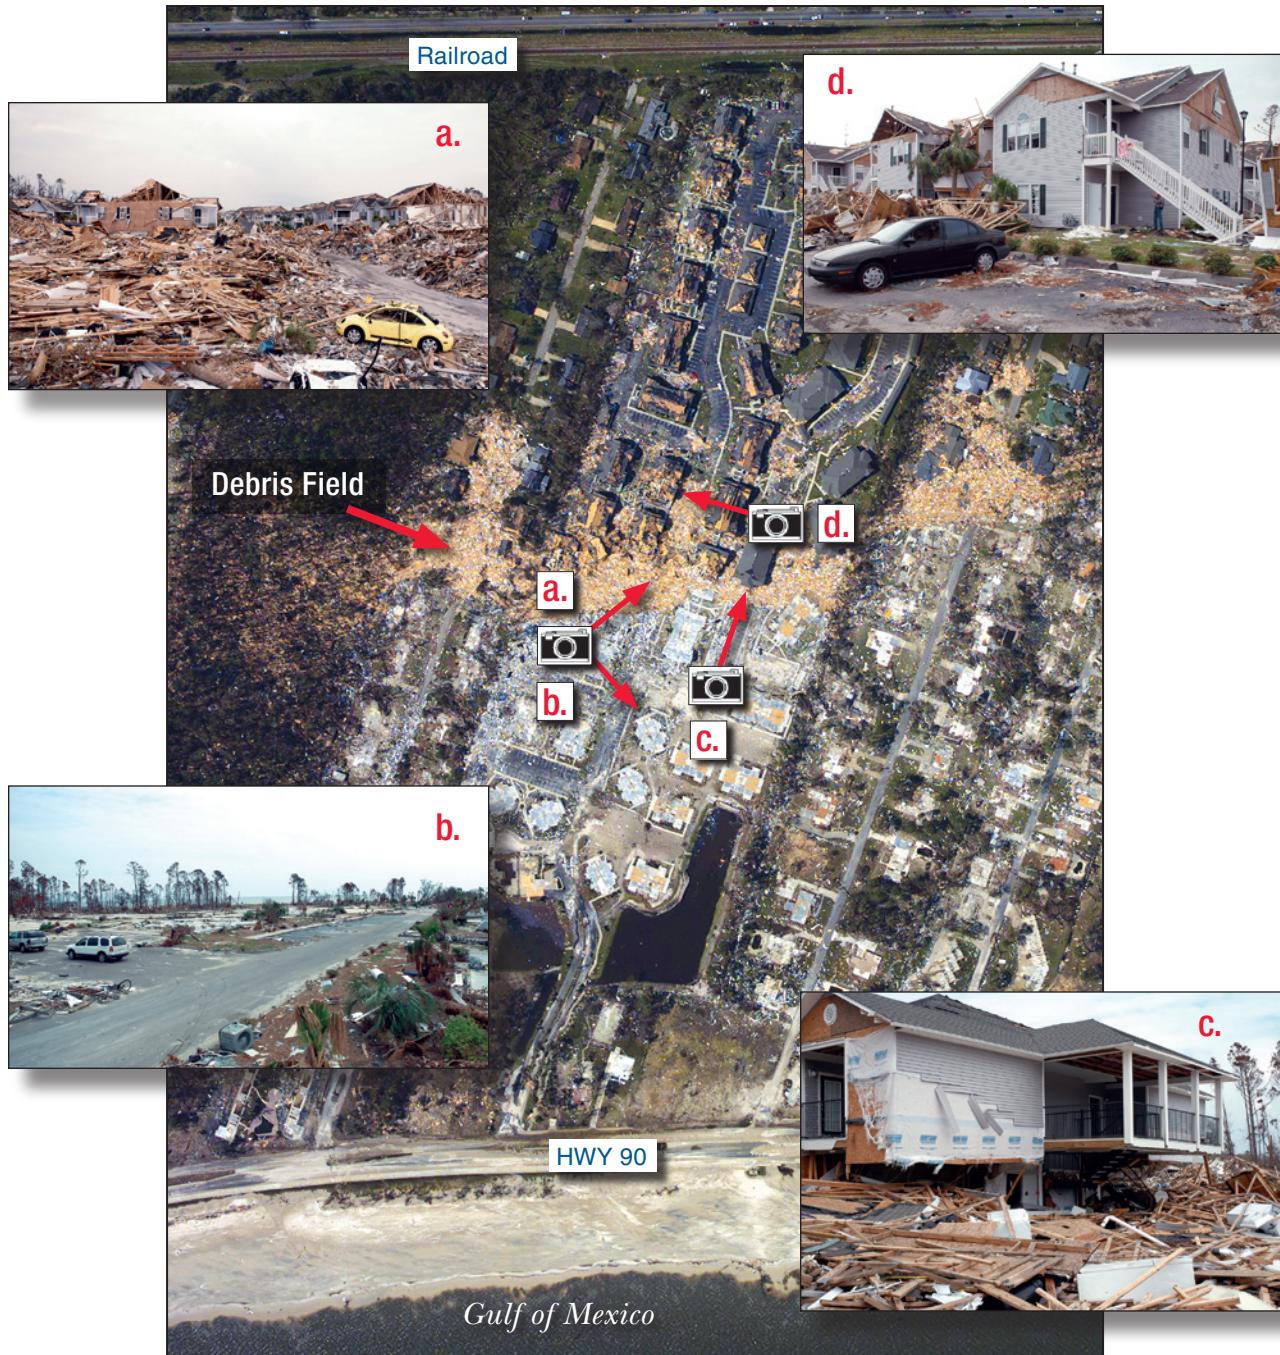
Katrina's high surge levels (and associated wave debris and wind conditions) completely destroyed apartment buildings constructed on slab foundations. Figure 4-53 shows multiple views of an apartment complex in Pass Christian. The red arrows on the aerial view indicate the point of view of the labeled closeups. The deepest flooding extended from the Gulf shoreline to the elevated railroad tracks at the top of the aerial image. The extent of the progressive failures moving inland from the Gulf is graphically identified by the upper limits of the debris field. The floating debris (a) consisted primarily of lumber from the destroyed buildings. All that remained of the seaward buildings were the slab foundations (b). The leading edge of the debris field combined with wave forces to progressively destroy the first- and second-story bearing walls

of the next remaining row of buildings (c). By the end of the storm, the floating debris field is thought to have grown so massive that it functioned as a breakwater, damping the waves from reaching the deeply flooded units, as shown by the watermark in (d), just landward of the debris field. Wind damage is apparent to the structures standing in (d), indicating that wind might have contributed to damage of the destroyed buildings seaward of the debris line.

Figure 4-53.  
Multiple views of an apartment complex on slab foundations. The red arrows on the aerial image indicate the point of view of the labeled closeups (Pass Christian, Mississippi).

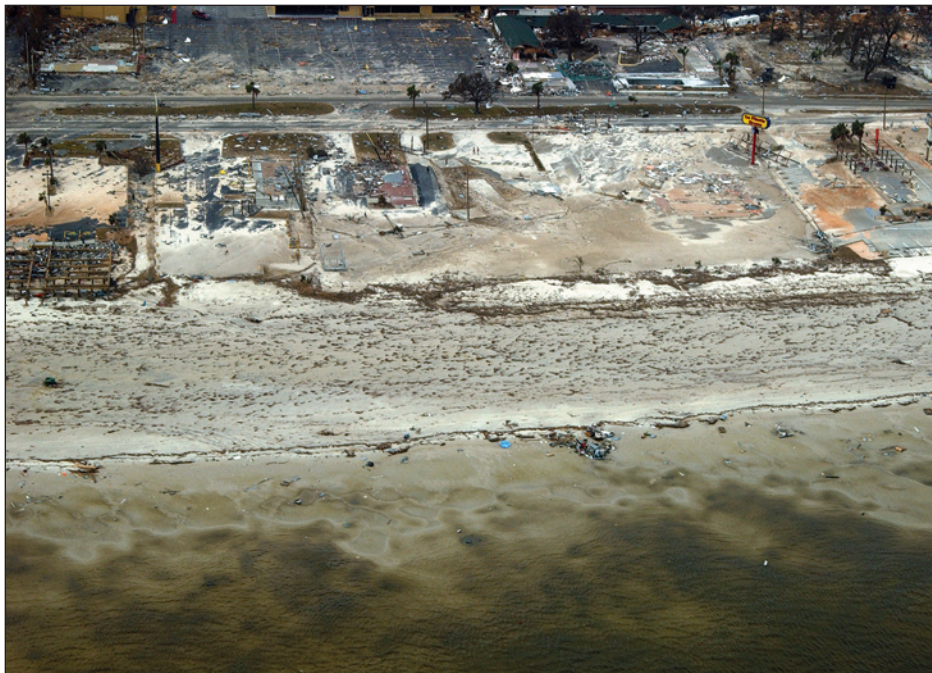
**Figure 4-54.**  
Commercial building  
destruction along the  
Mississippi coast

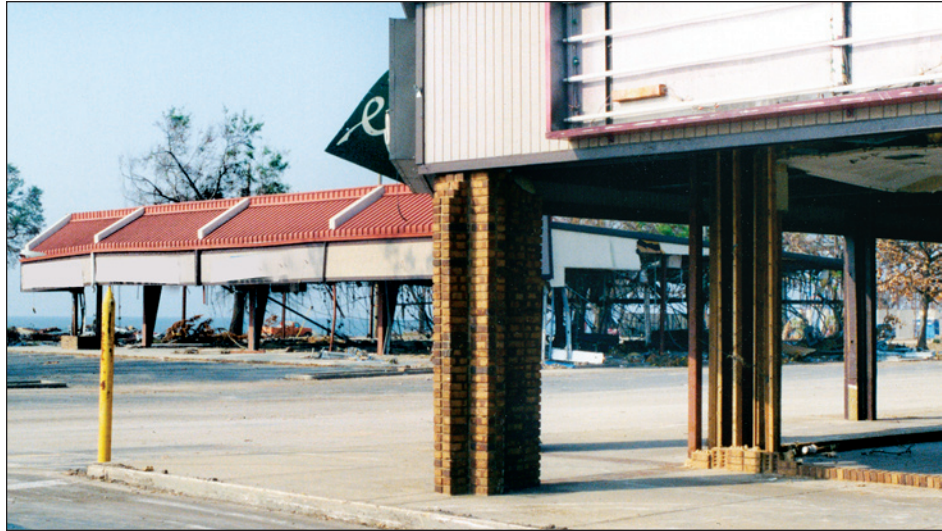
**Figure 4-56.**  
Interior of steel-framed  
strip mall construction  
shown in Figure 4-55  
(Gulfport, Mississippi)

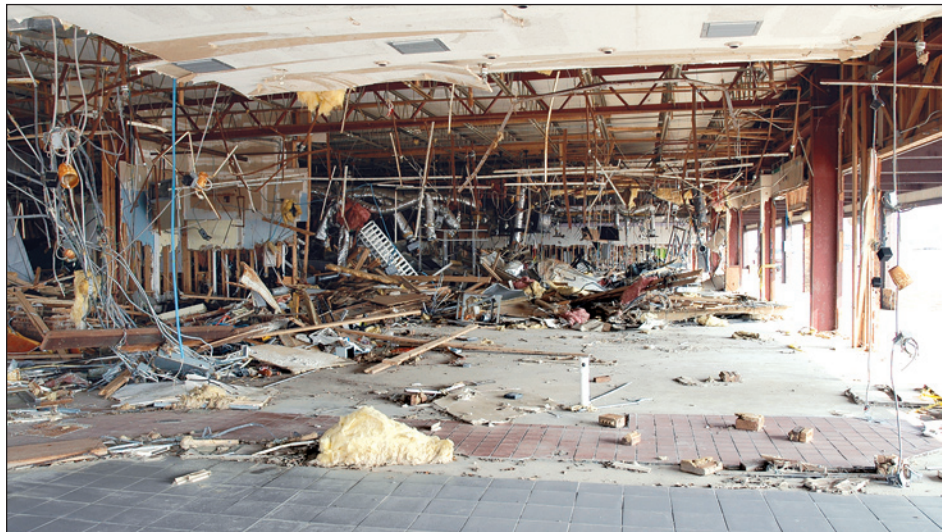
**Figure 4-57.**  
Steel-framed church that  
was gutted by waves, but  
the roof remained in place  
(Biloxi, Mississippi)

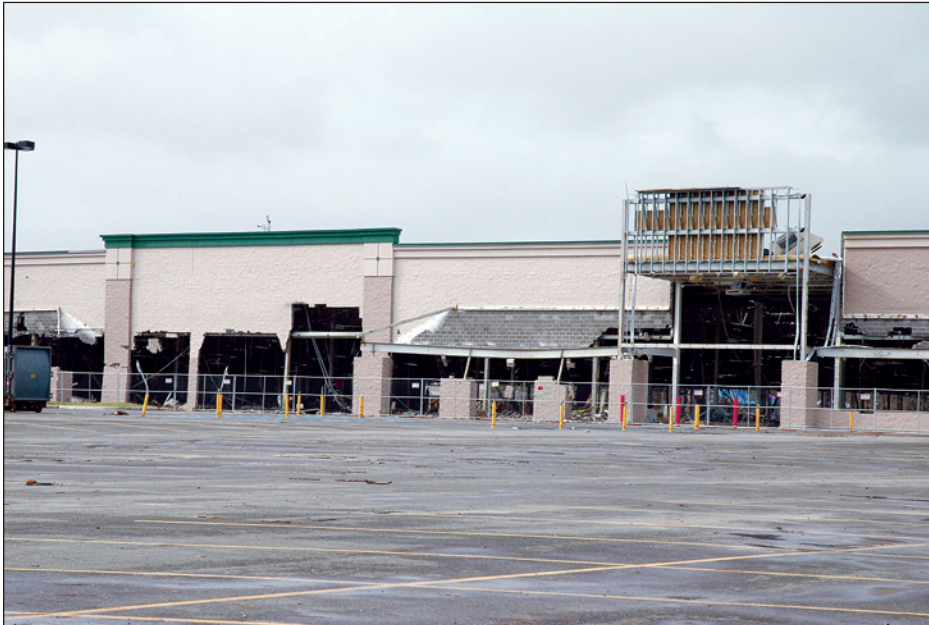
Figure 4-58.  
Large retail store that  
was gutted by waves,  
but most of the roof  
remained in place (Pass  
Christian, Mississippi)

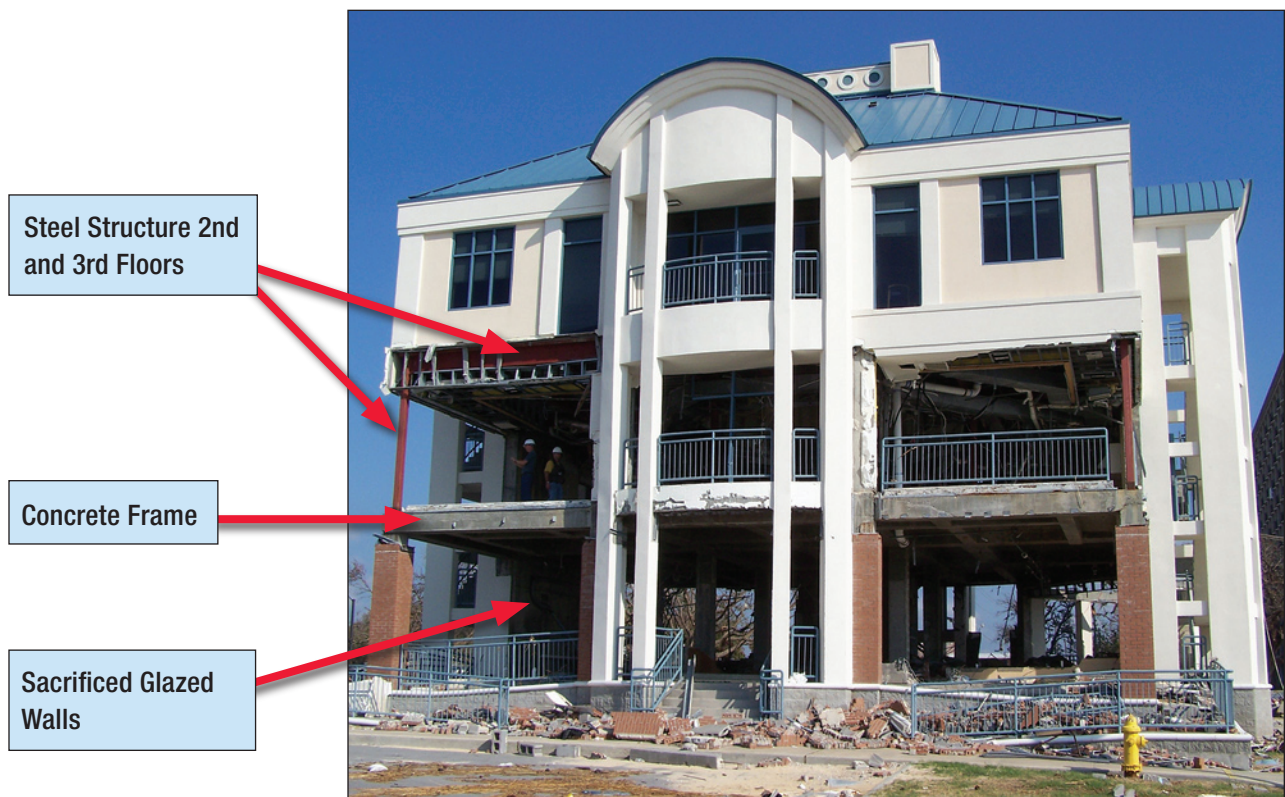
A very unusual commercial structure investigated by the MAT was the Biloxi Harbor Master Administration Building (see Figure 4-59). The building structure was a hybrid. Its lower level consisted of a reinforced concrete frame; the upper levels and roof were constructed with heavy steel structural columns and joists. The building was constructed in a designated V Zone, and the first floor walls of glass behaved like breakaway walls and were sacrificed with the storm surge.

Figure 4-59.  
Biloxi Harbor Master Administration Building with a hybrid structural system, concrete and steel (Biloxi,  
Mississippi)

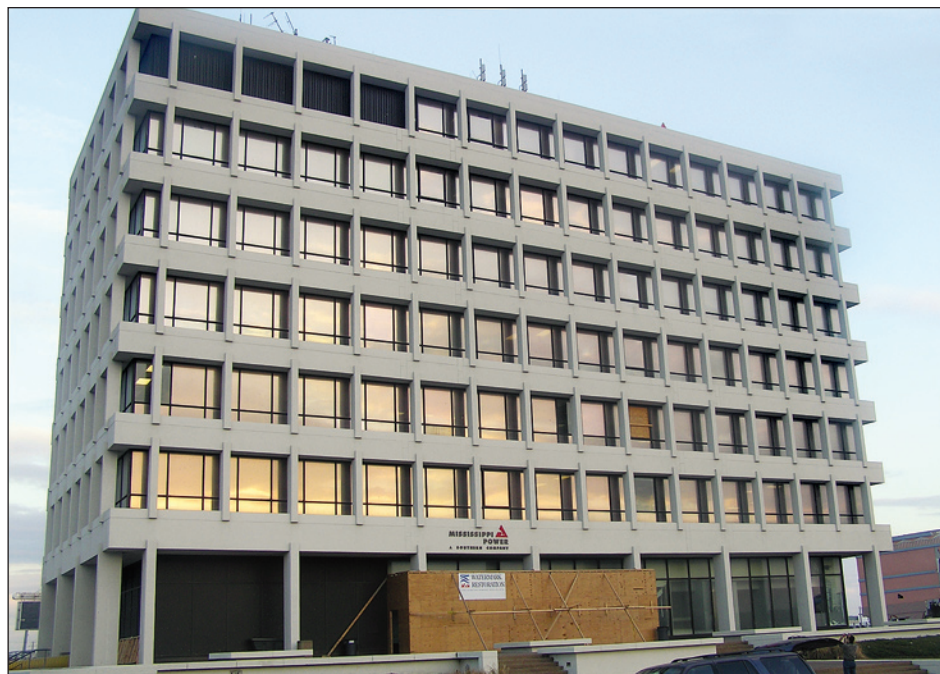
A concrete-framed building in downtown Gulfport (see Figure 4-60) sustained surge damage to its first floor and glazing damage from flying debris, but remained structurally sound and easily repairable.

**Figure 4-60.**  
Concrete-framed building sustained non-structural damage to lower portions from storm surge (Gulfport, Mississippi)

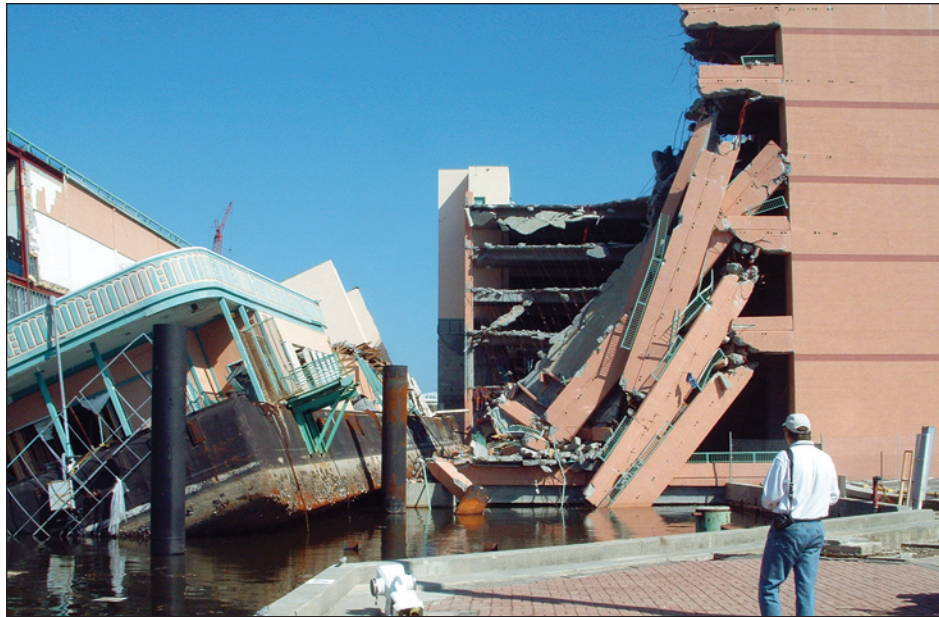
barges from their moorings to become massive floating debris. An example of barge damage to a hotel parking deck in Biloxi is shown in Figure 4-66. The consequences of other barge impacts is described in Chapters 3 and 6.

**Figure 4-66.**  
Parking deck collapse due  
to impact by casino barge,  
on left (Biloxi, Mississippi)

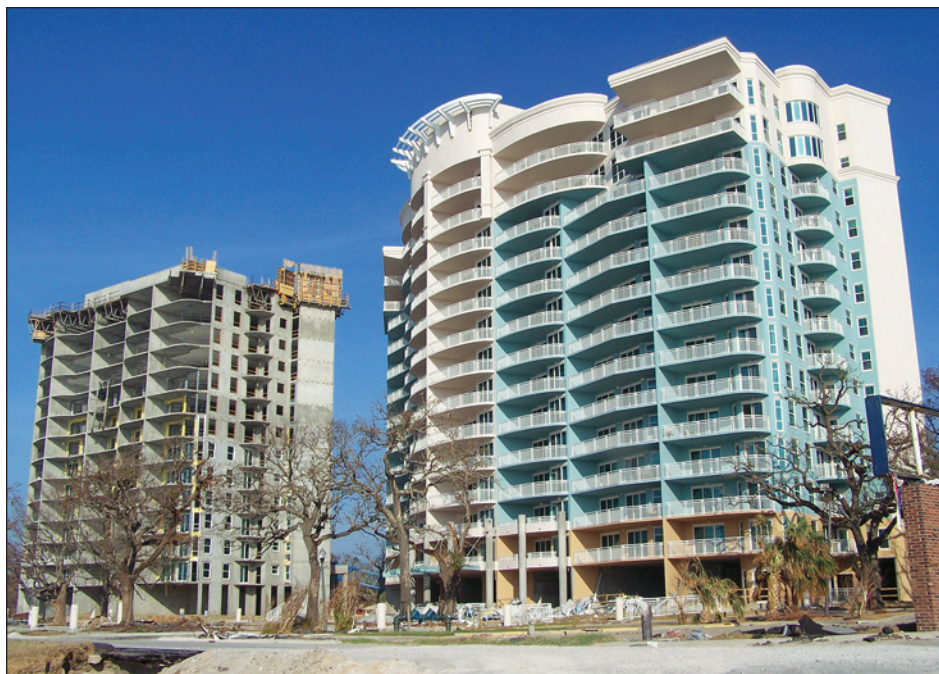
The MAT observed generally good structural performance of high-rise buildings located near the Gulf shoreline. The buildings observed included casinos/hotels, office buildings, and condominiums. High-rise foundation systems were generally not impacted by storm surge and wave impacts due to their location on high ground and building elevations. As an example, a high-rise building in Gulfport was sited on higher ground with a lower level office floor at elevation 20 feet NGVD (see Figures 4-67 and 4-68). One building was almost complete and the second tower was nearing completion. The cast-in-place concrete shear walls, aligned perpendicular to the shoreline, allowed waves to pass through the lower level, damaging only the office and other non-structural walls on the ground floor. The higher floors were undamaged.

**Figure 4-67.**  
High-rise building along  
Beach Boulevard received  
non-structural flood  
damage to lower floors,  
but no apparent flood or  
wind damage to higher  
residential floors (Gulfport,  
Mississippi)

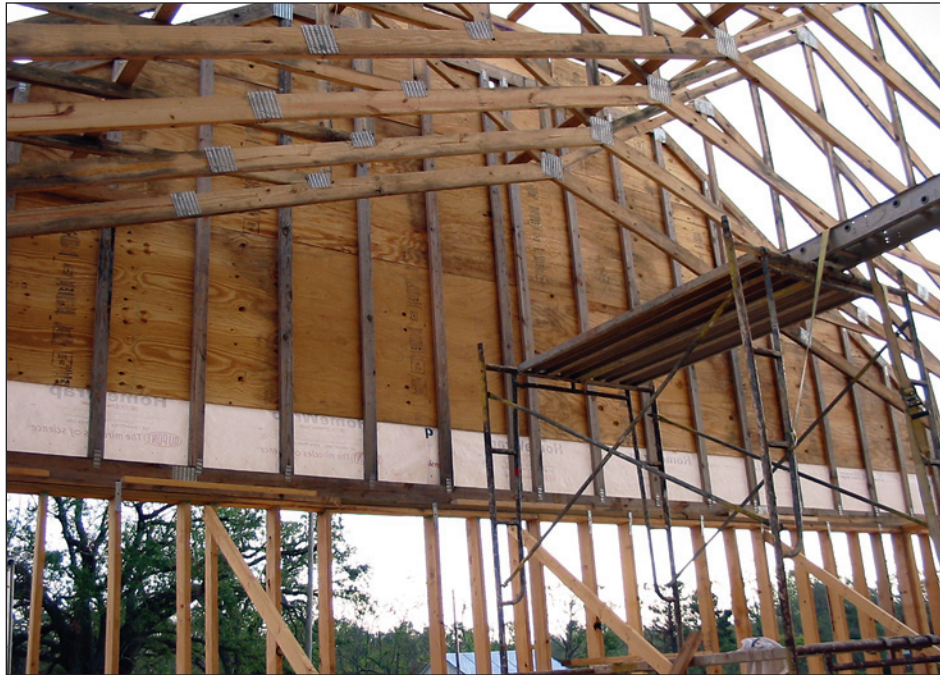
Figure 4-71

Observations of hurricane damage during the past few decades have revealed that a common failure point was wood-framed gable end walls. These were commonly under designed, improperly constructed, and unbraced. Often, a typical roof truss is the only support element behind the wall covering of the gable, as shown in Figure 4-70. Properly designed, fabricated, and installed trusses are usually designed to carry gravity loads across their strong axis. However, when a truss is used alone as the wall framing for the gable end wall, the truss members must resist the wall's wind forces along its weak axis. In many cases, the gable end may be as tall as a story high and, even if wall studs are added to the truss, the truss may still be inadequate to carry the shear and bending forces produced by the lateral wind load. Lateral bracing must also be considered in buildings using scissor trusses. Scissor trusses have sloped bottom chords that create vaulted ceilings. If the wall framing below the gable assembly is not continuous, a hinge can form and the wall framing can fail under lateral loads. The MAT observed new construction where inadequate wall framing was being provided (see Figure 4-71).

Inadequately braced gable on a building under construction (the building was not in place during Katrina). The trusses have sloped bottom chords (scissor style trusses) to create a cathedral vaulted ceiling. While the gable truss has a flat bottom chord, the wall studs below the bottom of the gable assembly are interrupted, which creates a weak hinge that will not adequately brace the top of the wall or the bottom of the gable truss above (estimated wind speed: 130 mph. Long Beach, Mississippi).

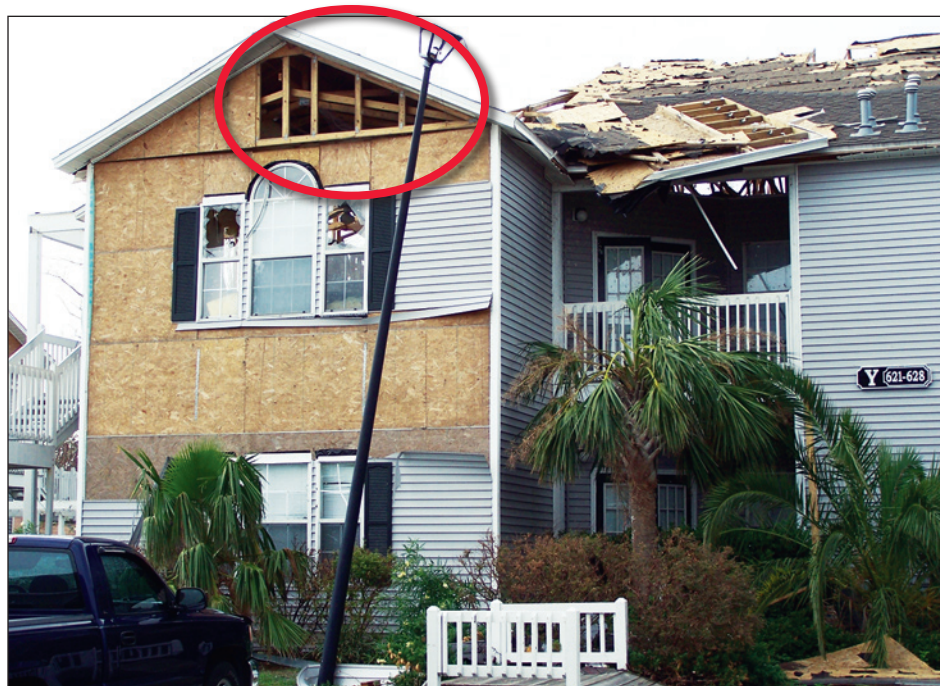
In cases where adequate wall stud framing is present in the gables, the problem is typically the absence of adequate bracing of the gable end wall, which sits on top of the wall below, as shown in Figure 4-72. Without adequate bracing, a hinge is produced between the bottom of the truss and the top of the wall, as seen in Figure 4-73. In most cases, the only bracing is the roof diaphragm, and when removed by the wind, total collapse of the roof and wall occurs as shown in Figure 4-74.

Apartment with typical gable end wall truss with stud infill. Note the loss of gable sheathing and the lateral displacement of the bottom chord of the truss (circle) (estimated wind speed: 120 mph.<sup>6</sup> Ocean Springs, Mississippi).

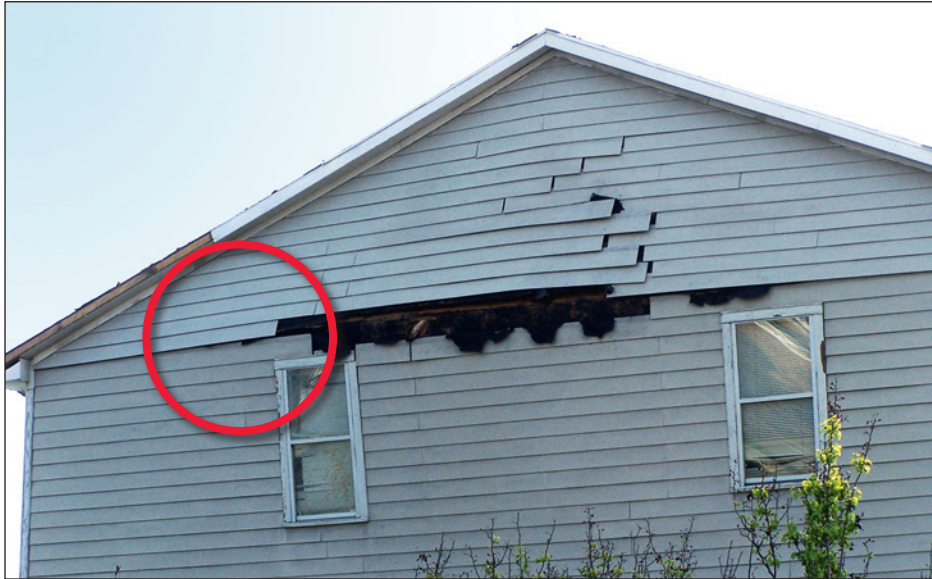
Figure 4-73.  
Hinge formed between  
gable end and top of wall  
(hinge circled)  
(estimated wind speed:  
120 mph. Ocean Springs,  
Mississippi)

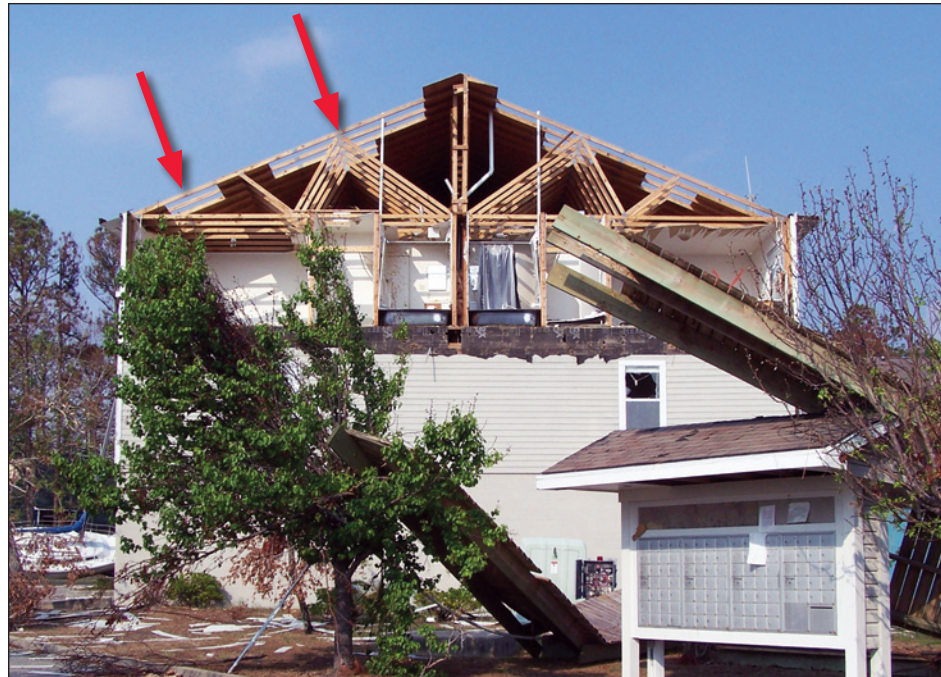
The most common wind-related structural failures observed in light-framed construction were roof framing failures. Failures were observed in both new and old construction. Insufficient attachment of roof sheathing panels to the supporting framing was the most common problem. Before the 1982 SBC, the code did not account for higher uplift pressures that occur at roof perimeters and corners. Much closer nail spacing was required after implementation of the 1982 SBC criteria. Once the sheathing attachments fail, a variety of other failure modes can occur. Attics that have been breached can become pressurized and other structural elements may then become overstressed. This can lead to an “unzipping” effect of progressive failure where one failure leads to a series of subsequent failures, as seen in Figure 4-75.

**Figure 4-75.**  
Failure of the gable end wall of this apartment building led to pressurization of the attic and the release of sheets of plywood sheathing. Note the plywood roof sheathing “unzipped” by wind pressures (arrows) (estimated wind speed: 120 mph. Ocean Springs, Mississippi).

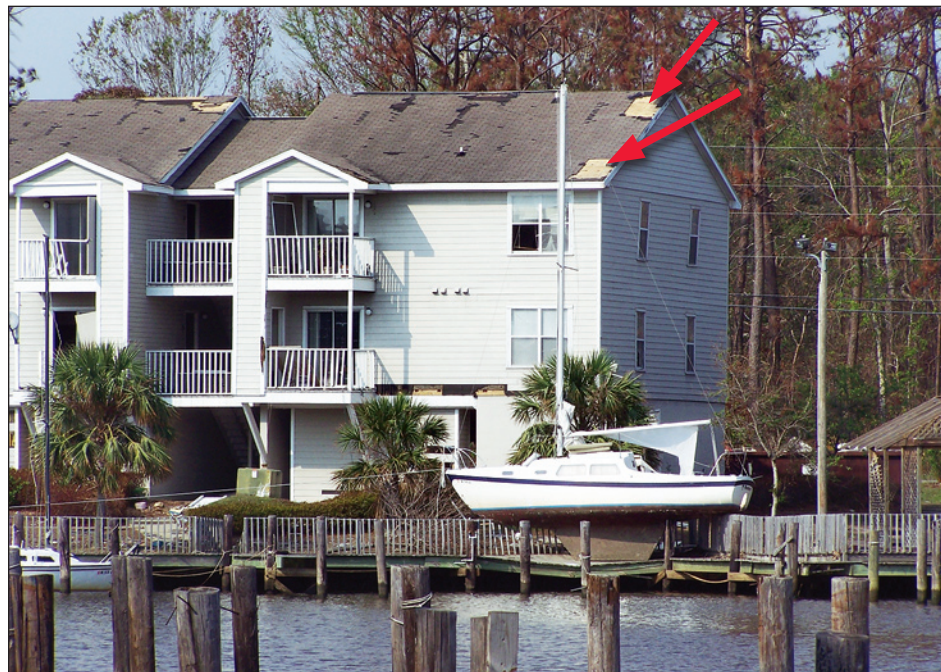
**Figure 4-76.**  
Roof corners, edges, and ridges are zones of increased wind pressures (arrows), as seen in this apartment complex (estimated wind speed: 120 mph. Ocean Springs, Mississippi).

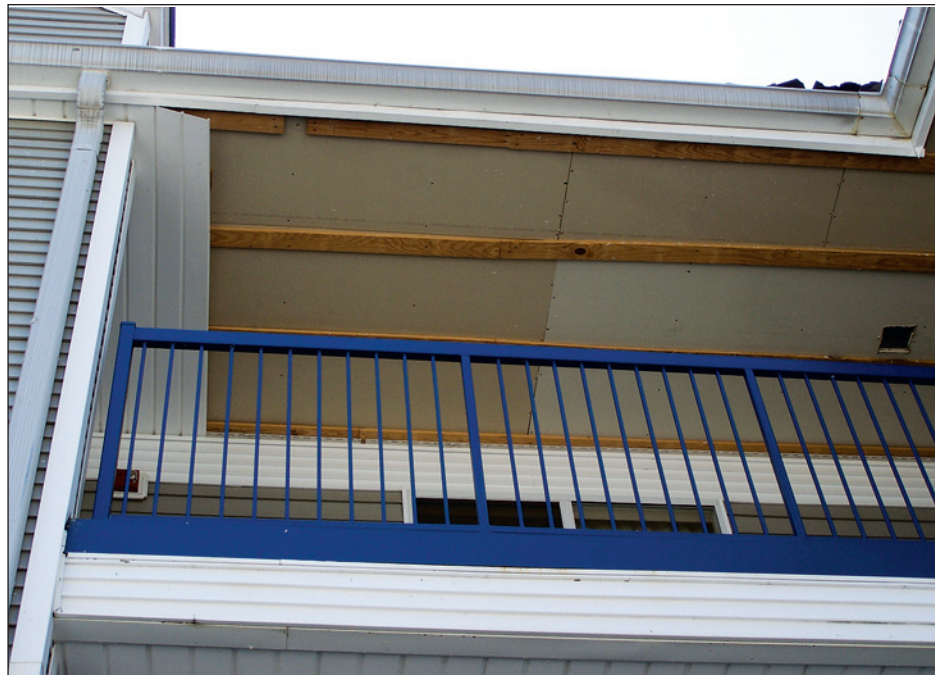
The MAT observed numerous examples of failures of building soffits that led to attic internal pressurization and subsequent loss of decking and roof framing members, as seen in Figure 4-78. Soffits supported by solid substrate, seen in Figure 4-79, often prevented significant air pressure from entering inside the building envelope.

**Figure 4-79.**  
Properly attached  
gypsum board  
substrate avoided attic  
pressurization and  
entrance of wind-driven  
rain when the finish  
soffit material was lost  
(estimated wind speed:  
120 mph. Ocean Springs,  
Mississippi).

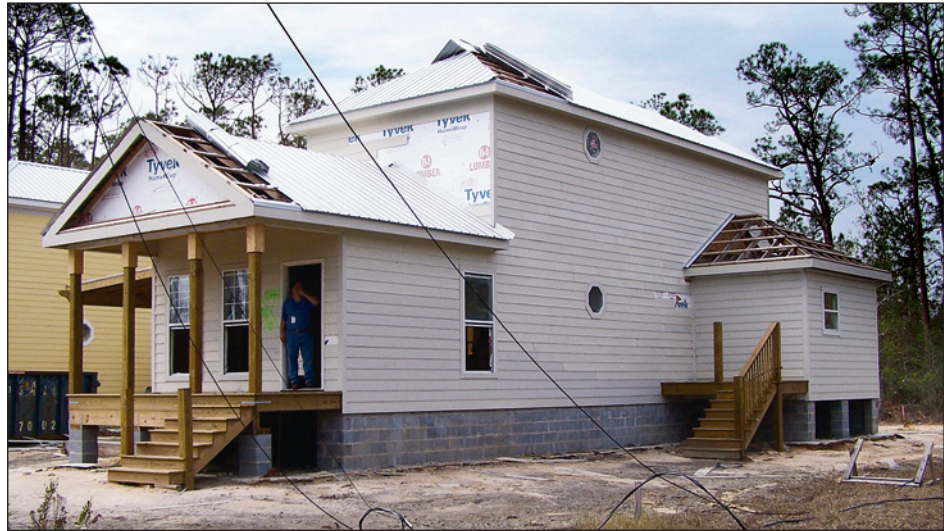
Figure 4-82.  
Home under construction  
subjected to flood and  
wind damage (estimated  
wind speed: 130 mph. Pass  
Christian, Mississippi)

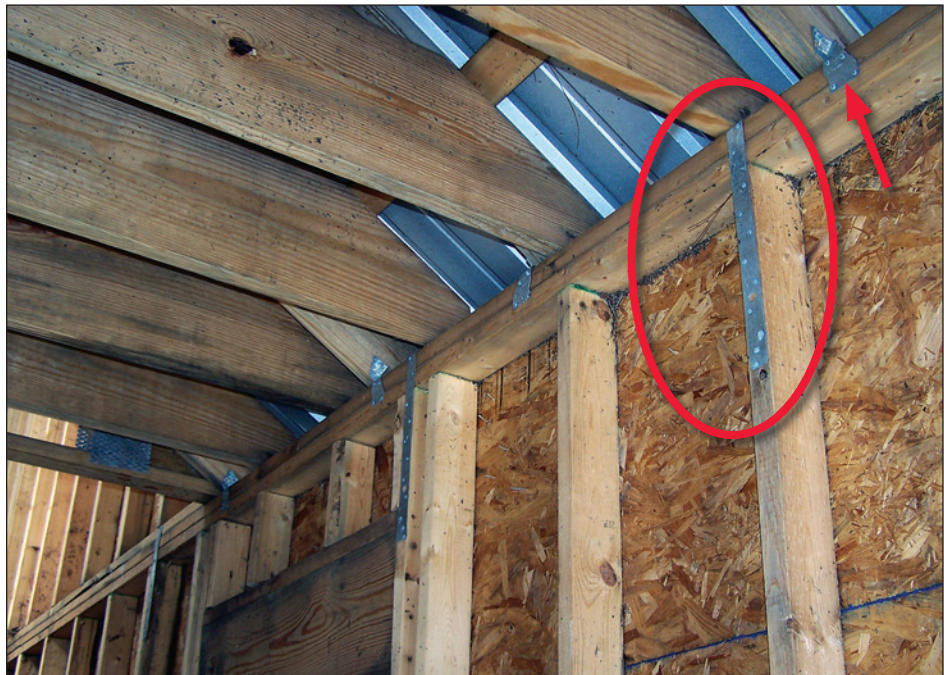
Figure 4-83.  
Home located in Exposure  
C with rafter-wall  
connectors and top plate-  
stud connectors. Note the  
rafter-top plate connector  
(arrow) is more effective  
to install on opposite side  
of wall, and the top plate  
stud connector (circle)  
(estimated wind speed:  
130 mph. Pass Christian,  
Mississippi).

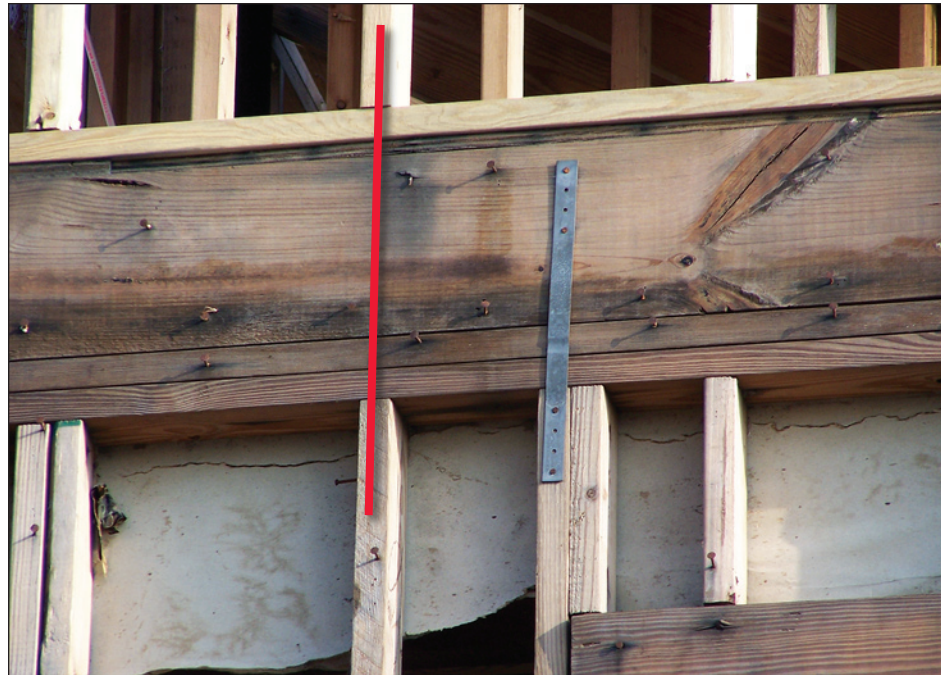
Figure 4-86.

Floor-to-floor straps are intended to keep the load path connected (proper strap location in red). The strap installed in this Biloxi office condominium does not extend to the upper wall system and is insufficiently nailed (estimated wind speed: 120 mph. Biloxi, Mississippi).

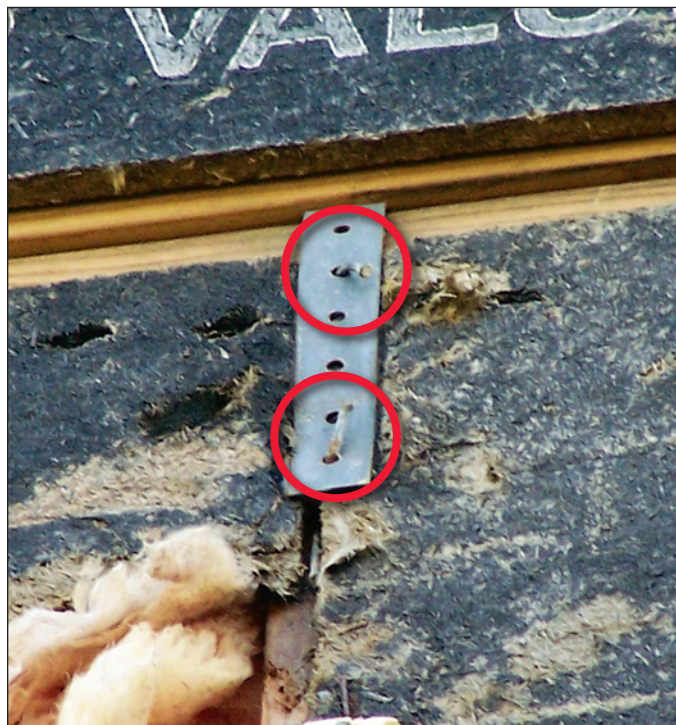
Figure 4-87.

Stud strap connected to top plate with improperly sized nails with bent heads (circles). The strap did not extend far enough down the stud and several fasteners were missing (estimated wind speed: 120 mph. Ocean Springs, Mississippi).

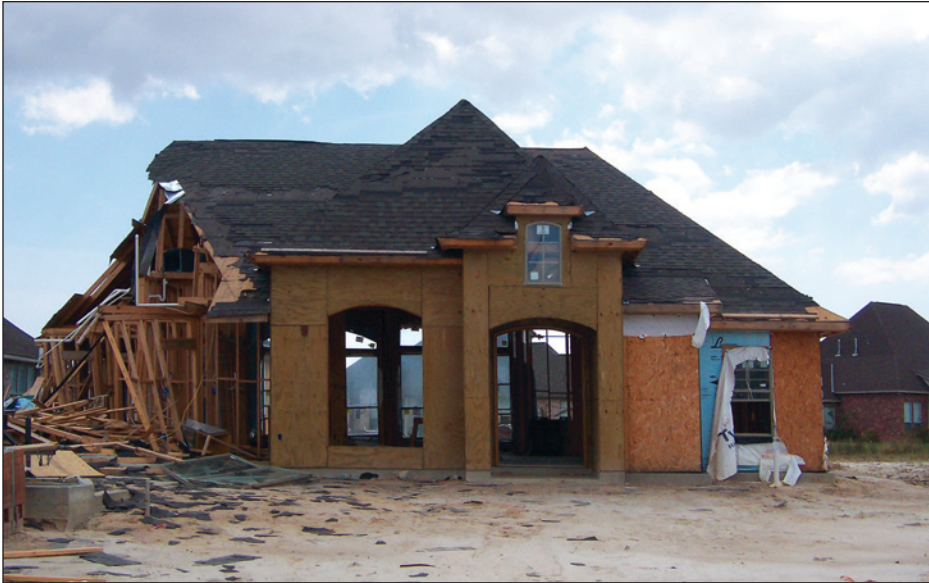
Some homes under construction were severely damaged or destroyed by Katrina's winds even though wind speeds were well below current design levels. Figure 4-88 shows a home in St. Tammany Parish with failed shear walls and a collapsed garage. The complete destruction of the garage prevented the MAT from determining the mode of failure, but the failure of the home could be attributed to inadequate shear wall nailing. The home had shear walls that were only stapled and the staples were widely spaced. Several staples missed the wall framing.

Figure 4-88.  
Home under construction whose garage collapsed and that racked laterally approximately 1 foot. Sheathing in the shear walls in the front of the home were found to be inadequately fastened to the wall framing (estimated wind speed: 120 mph. St. Tammany Parish, Louisiana).

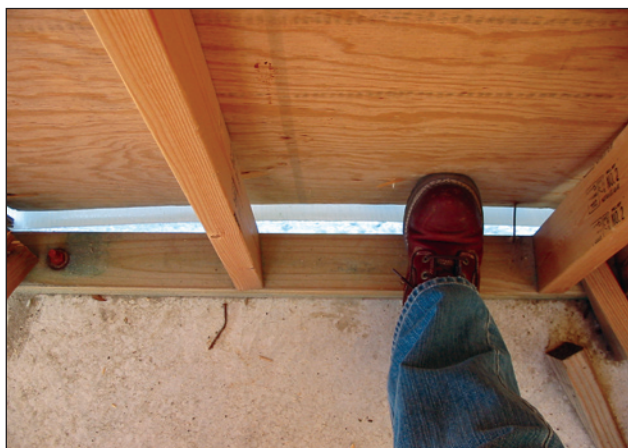
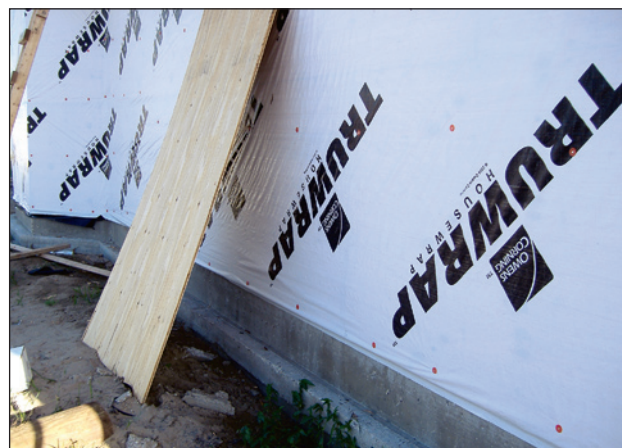
Figures 4-91 (a) and 4-91 (b) show a home in St Bernard Parish, Louisiana, that did not experience significant damage during Katrina (it is possible that the home was constructed after Katrina), but was indicative of improper construction methods found in several new homes the MAT visited. Wall sheathing in the home was fastened to the bottom wall plate at 32 inches on center while prescriptive codes would require nailing at 6 to 8 inches. The presence of building wrap on the outside walls indicates that no additional nailing was to be installed.

**Figure 4-91 (a) and 4-91 (b).**  
Wall framing was inadequately secured to the bottom plate with fasteners spaced over 32 inches on center. The presence of building wrap shows that no additional nailing was planned (estimated wind speed: 130 mph. St. Bernard Parish, Louisiana).

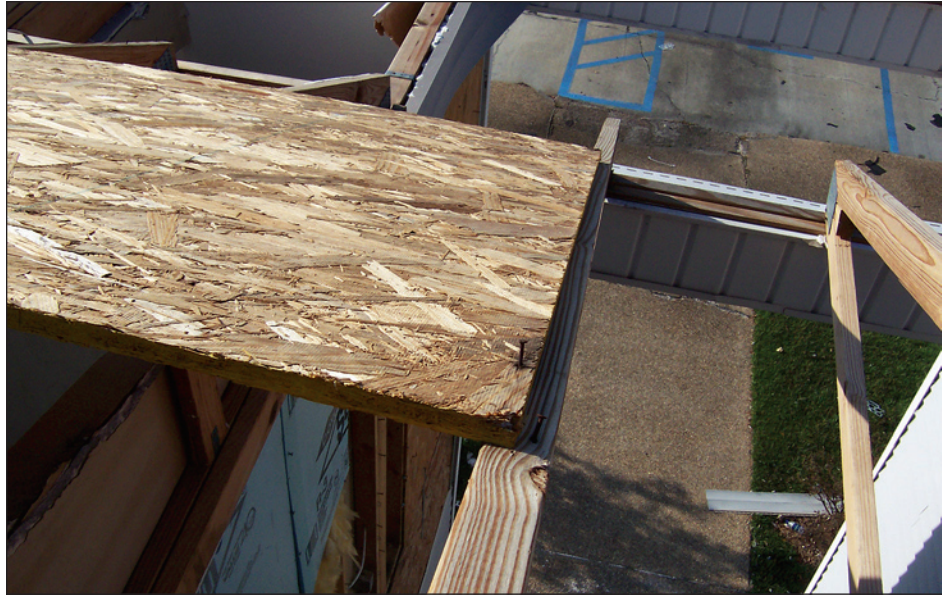
The MAT observed several damaged buildings where roof sheathing was tacked at corners with nails and fastened with staples in all other areas of the sheet (see Figures 4-92 and 4-93). Staple placement varied greatly and often one leg of the staples missed the roof framing. Where staples were squarely fastened to roof framing, some staples tore through the sheathing when the roof sheathing experienced pull-through failure, as shown in Figure 4-94. The 2003 IRC allows cellulosic fiberboard wall sheathing to be stapled along panel edges at 3-inch centers (on 6-inch centers within the panel), but specifies nails for fastening structural wall and roof panels.

**Figure 4-94.**  
Roof sheathing attachment was inadequate. Several staples were missing, some staples missed framing, and inland the sheathing pulled over the staples (estimated wind speed: 130 mph. Long Beach, Mississippi).

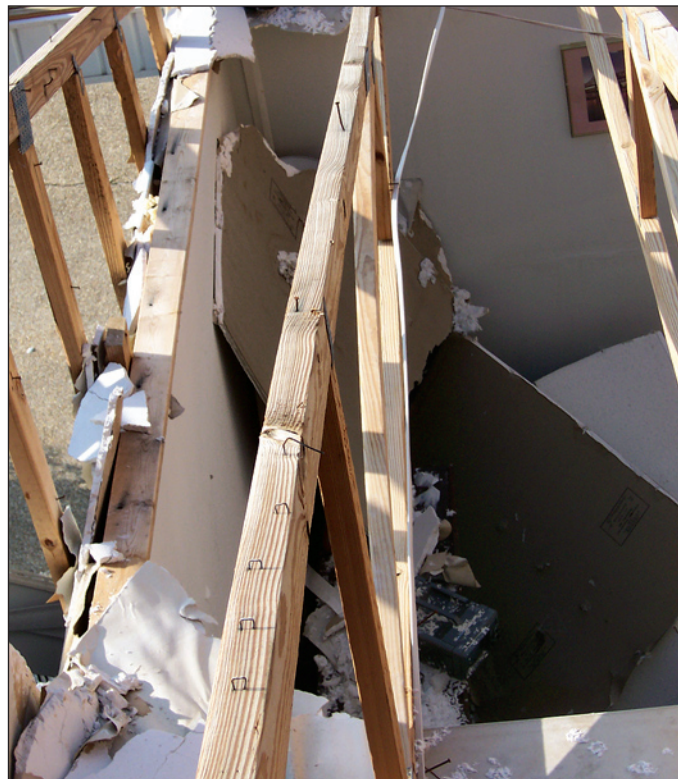
Metal connectors were frequently left out, or were installed improperly. In a Long Beach apartment complex, connectors were used to anchor the main trusses to the bearing walls, but none were used on the gable trusses above the entrances and porches (see Figures 4-95 through 4-98). In those areas, the wide eaves and open breezeways were subjected to uplift forces on the trusses on several buildings in the complex. Connections failed and entire roof structures above the entrances and porches blew off of the buildings.

**Figure 4-96.**  
Metal connectors were lacking on the gabled roofs over the porches and entrances. Several roof structures were blown off (estimated wind speed: 130 mph. Long Beach, Mississippi).

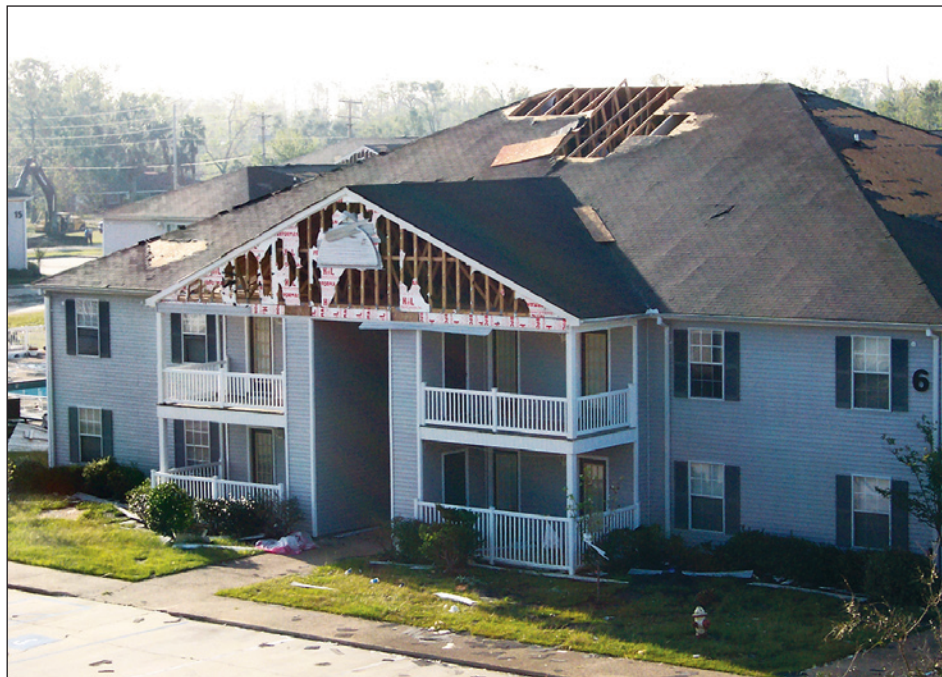
Gable end walls were often constructed with vinyl siding over rigid insulation sheathing, which is vulnerable to damage from wind and windborne debris. If the gable walls are penetrated, internal pressurization occurs and uplift forces on the trusses increase. Properly fastened plywood sheathing on the gable walls would have improved performance and may have prevented failure.

Figure 4-98.  
Apartment building's gable walls sheathed with insulation failed during Katrina (estimated wind speed: 130 mph. inland Long Beach, Mississippi)

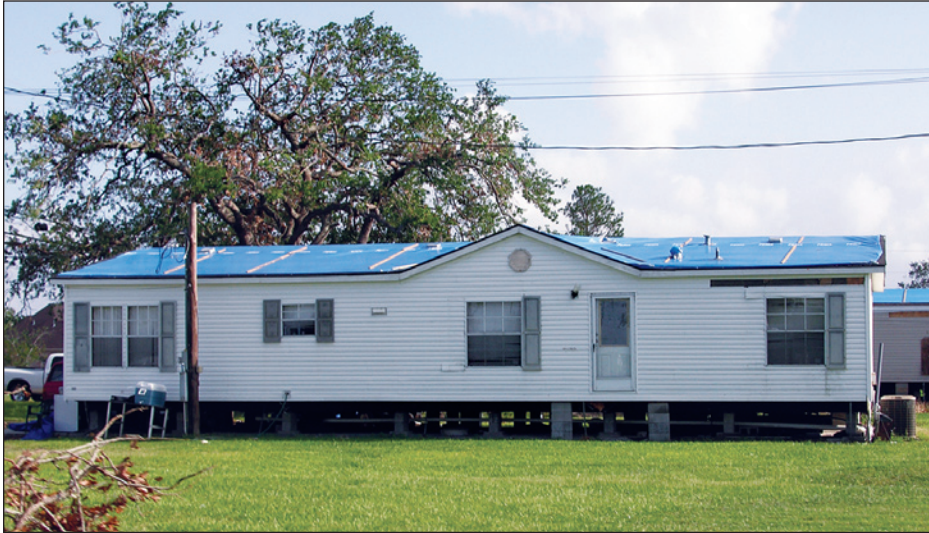
Figure 4-103.  
Newer manufactured home located in Exposure C with roof covering damage (estimated wind speed: 110 mph. Plaquemines Parish, Louisiana)

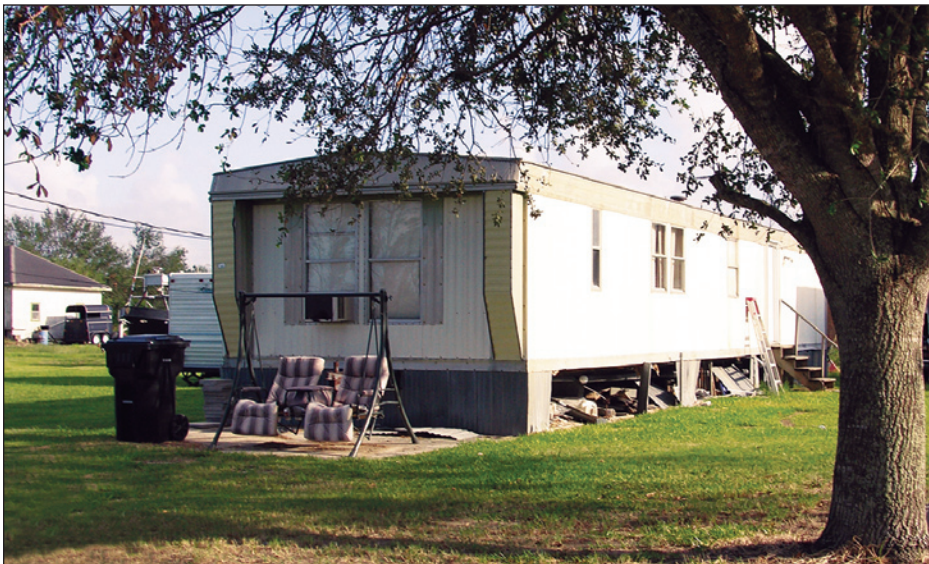
The styles of manufactured home installations impacted performance during Hurricane Katrina. When properly anchored, manufactured home damage under wind loads was less significant. Unanchored or improperly anchored homes or homes with damaged anchors were prone to wind-related damage. The home in Figure 4-104 was installed with ground anchors. The heads of the ground anchors extended several inches above the ground (see Figure 4-105). The straps that connect the ground anchors to the frame were loose and would allow the home to move several inches before the ground anchors would begin to resist wind loads.

Figure 4-104.  
Manufactured home located in Exposure C installed with ground anchors (estimated wind speed: 110 mph. Plaquemines Parish, Louisiana)

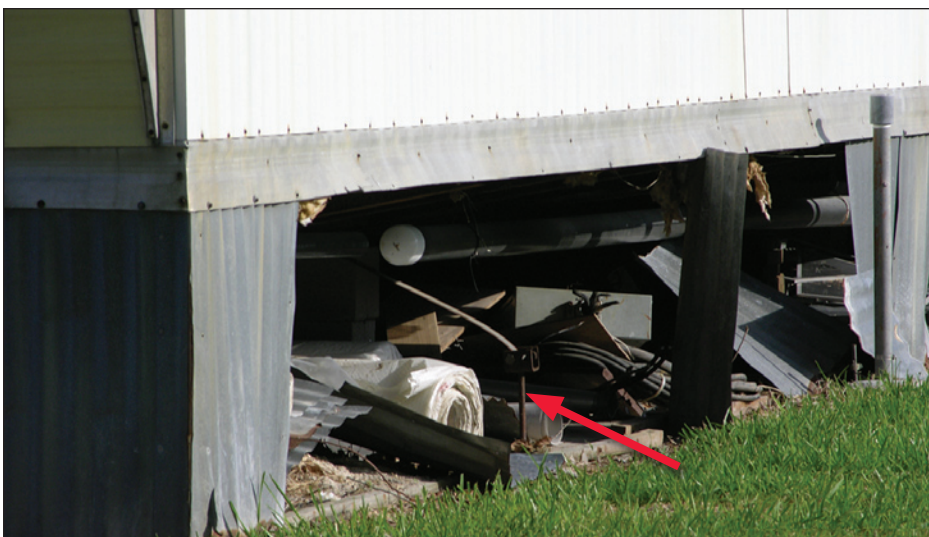
Figure 4-105.  
Ground anchors at manufactured home located in Exposure C (estimated wind speed: 110 mph. Plaquemines Parish, Louisiana)

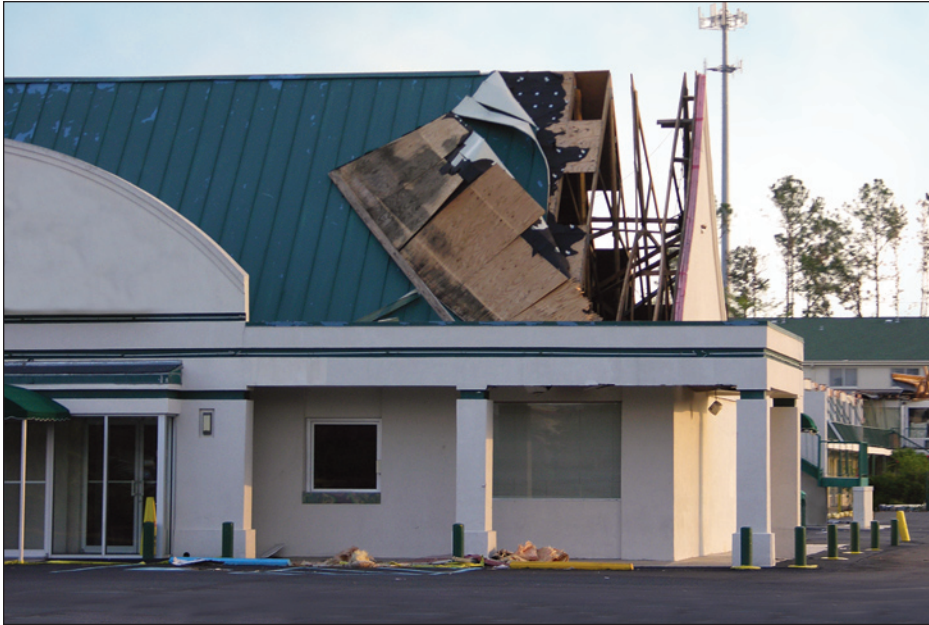
Figure 4-108.  
Roof uplift failure  
in wood-framed  
commercial building  
(estimated wind speed:  
115 mph. Slidell,  
Louisiana)
